East Wichel Canal – Spring 2022 Update

Towards the end of 2021 initial repairs were made to the canal in East Wichel. These works along with the remainder of the canal have been monitored over the winter to test the repairs effectiveness. This note provides an overview of the findings and summarises the next steps.

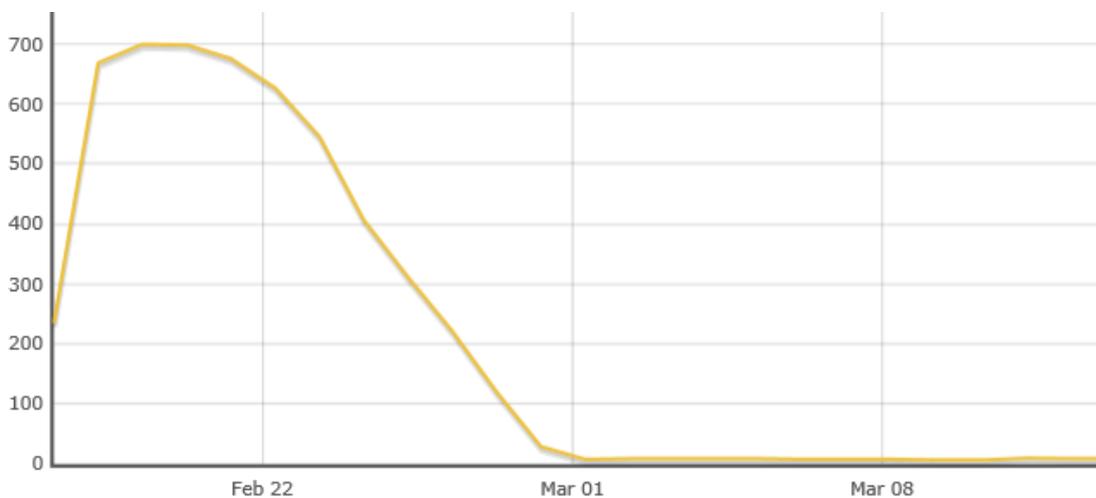
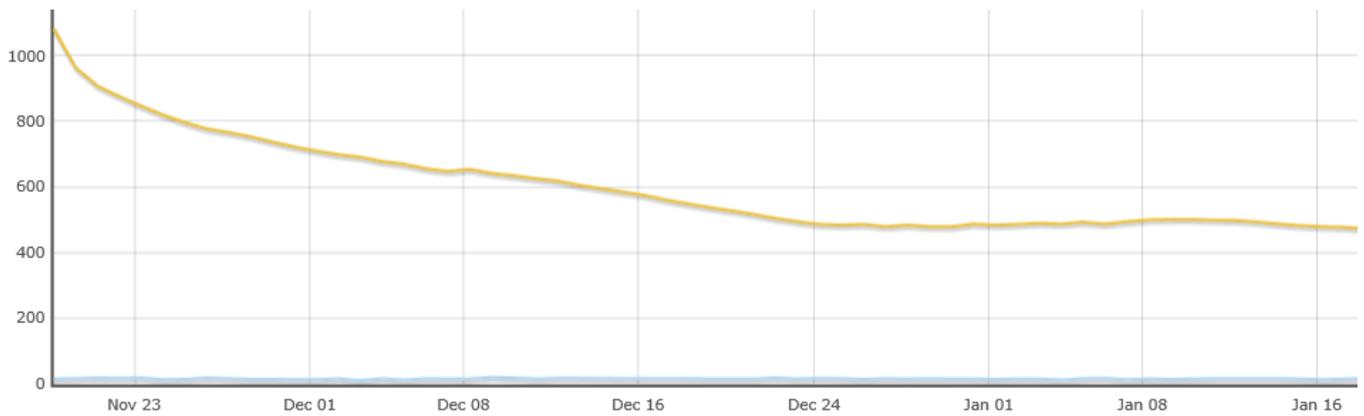
The first graph from Feb/March 2021 shows the canal completely emptying (from a depth of 700mm) in 9 days. The second graph shows a fairly rapid drop over the first few days and then a levelling out. Both periods had relatively low rainfall.

These readings provide positive evidence that the main leak in the base of the canal has been fixed. The water is however still dropping at a faster rate than either of the adjoining sections.

The section between bunds E to G has been the key focus, as the previous monitoring showed levels falling fastest in this area. In November this section was emptied and an area adjacent to the culvert where water was leaking from the base of the canal identified. The banks either side of the bridge also looked to be lacking in clay and these were therefore reconstructed to improve both bank stability and water tightness.

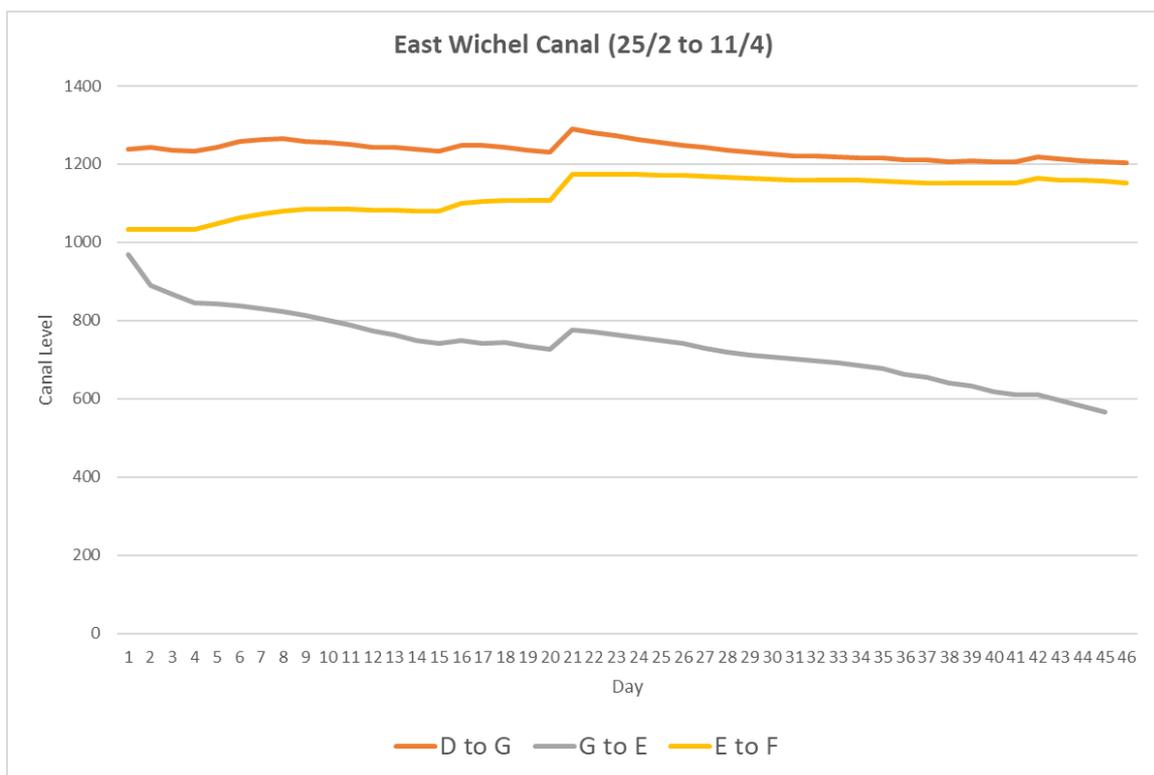
This second test showed another initial drop but a period of heavy rainfall meant the date was not directly comparable to previous tests. The levels have however continued to drop faster than adjacent sections.

Further visual inspections of the banks have been carried out in addition to trial holes on the southern bank but these have not yet identified the problem. It has however been noted that an area of the bank does have a higher moisture content which has informed the next stage of investigation.

Focussing on Section E to G we will be excavating a number of trenches on both the north and south of the canal and assessing for water inflow after a defined period (expected to be one or two days). This will help to narrow down and identify areas where water is leaking through the banks.

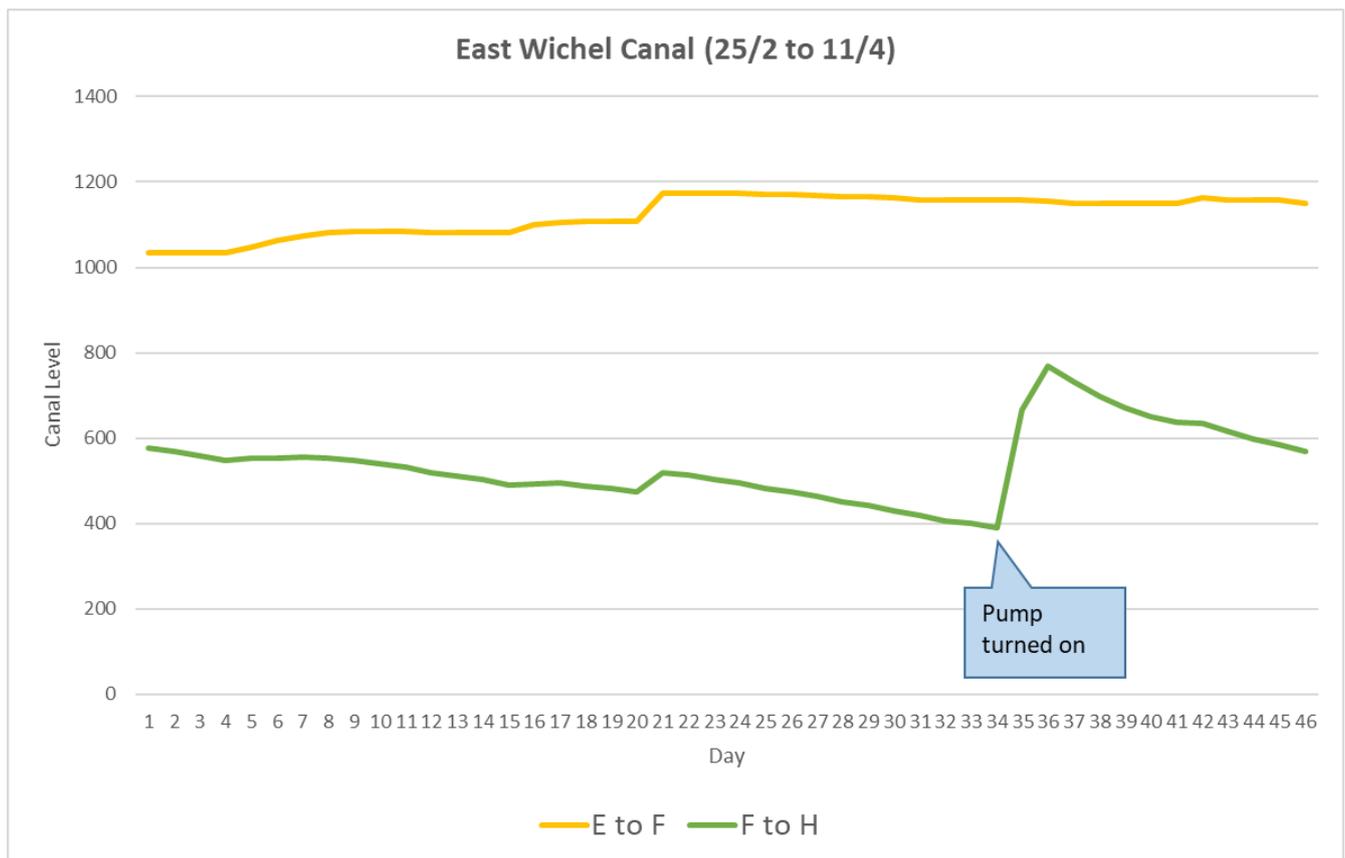
The graph below shows the two sections closest to the lock and shows water being lost at quite a high rate.

It appears that water is being lost through the lock so we are not yet confident that the readings from the most western section are accurate. It does however appear there may be an issue in section F to H as when compared to its eastern neighbour (section E to F) there is greater water loss.

As part of the next section of works we are planning to install two further bunds either side of the aquaduct to narrow down and test these sections. As the tie in with the structure was an issue in the section E to G this is our first area for further investigation.
