East Wichel Canal – Spring 2022 Update

Towards the end of 2021 initial repairs were made to the canal in East Wichel. These works along with the remainder of the canal have been monitored over the winter to test the repairs effectiveness. This note provides an overview of the findings and summarises the next steps.

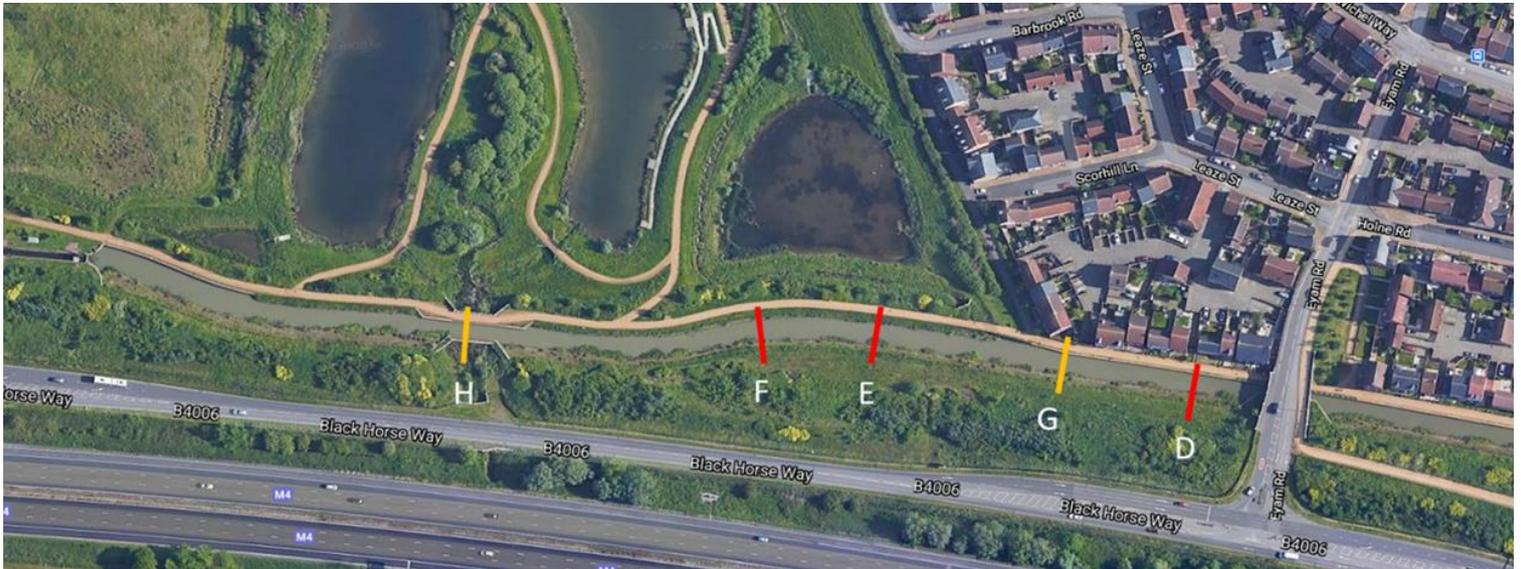
The canal has been split into a number of sections with each bund allocated a letter. Over the winter additional monitoring stations were added and daily canal level readings collected from each section.
